Building Safety Tip * Vent Connectors

Check Condition of Appliance Vent Connectors

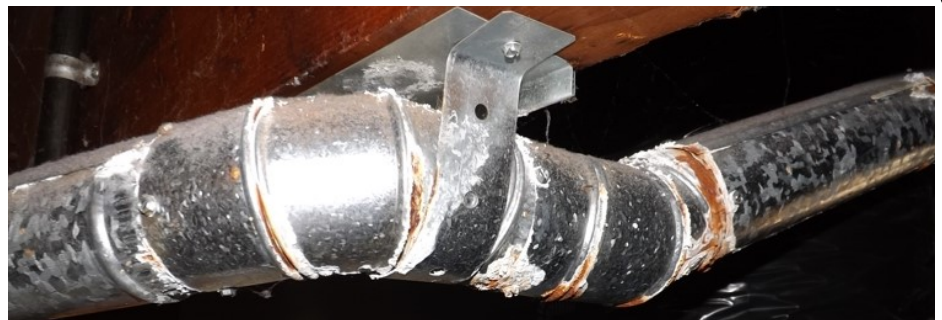
The Warning Signs:

- Visible Holes
- Too Close to Wood/Combustibles
- Corrosion/Rust
- Loose Connections/No Screws
- No Support Hangers

A faulty appliance vent connector can allow dangerous fumes to enter the home. Carbon Monoxide is a colorless, odorless gas which can be deadly at high concentration levels. Headache, dizziness, and nausea are some possible symptoms of carbon monoxide poisoning. Check wood surfaces near vent connectors for discoloration & scorching. A single-wall vent connector is a fire hazard if located too close to wood and other combustible materials. If you observe the warning signs, have a licensed contractor evaluate the venting system and perform any necessary repairs.
